A Re-Design Proves to be the Best Solution

Whitemud Drive Retaining Wall, Edmonton, Alberta, Canada

by Martin Halliwell, P. Eng.,
Project Manager, HCM Contractors
Inc. and
Mark Spence, E.I.T., Project Manager,
Isherwood Associates

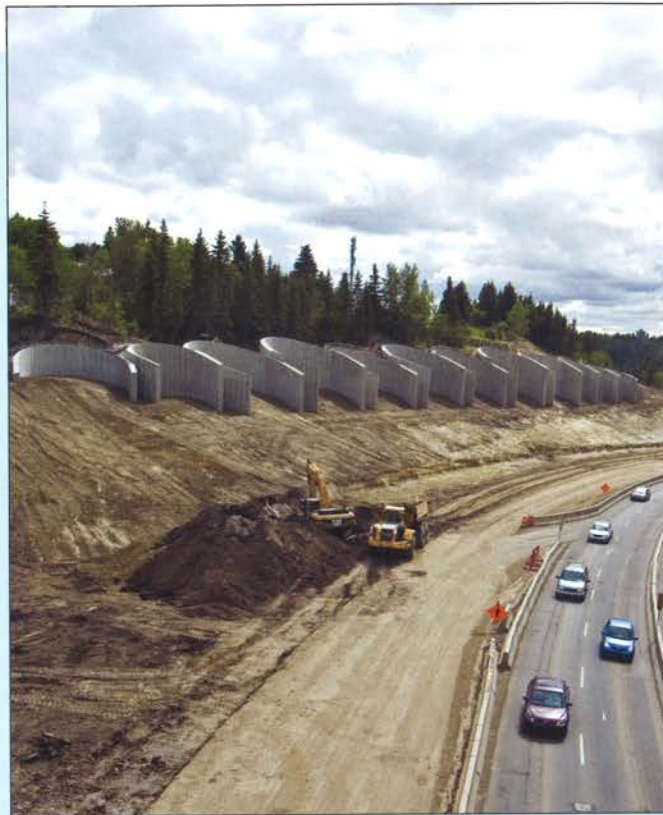
The completed shoring wall adjacent to Whitemud Drive.

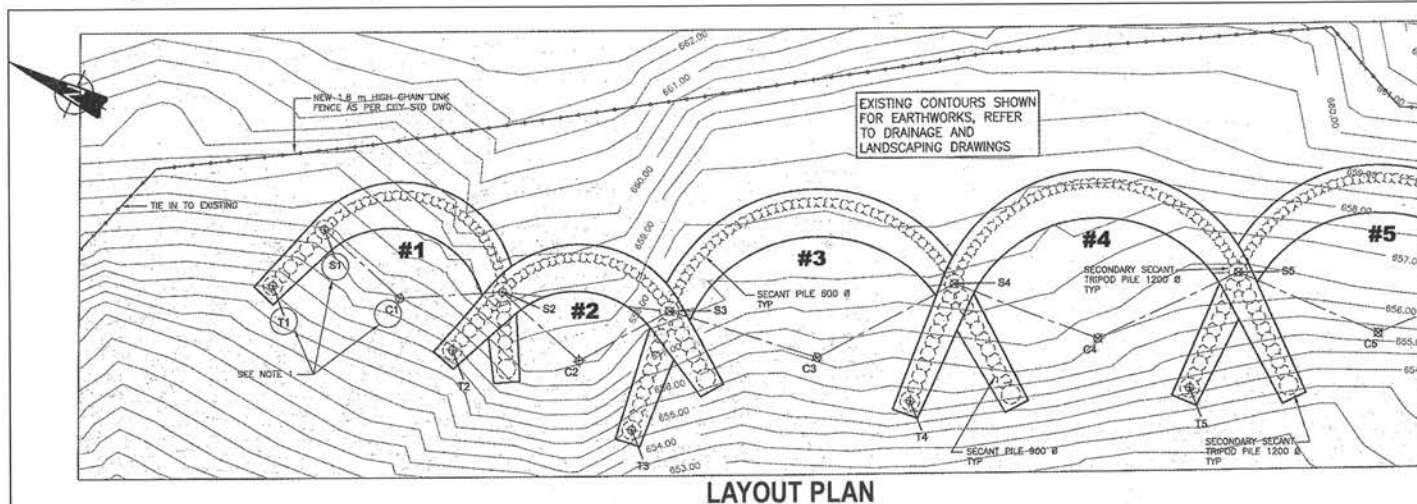
Figure 1: Tendered Design of the Whitemud Drive Retaining Wall.

The HCM/Isherwood design-build team's innovative design for the retaining wall was proposed to the City of Edmonton as an alternative to the original tender. Figure 1 shows the original design concept: a series

of high-strength, interlocking secant walls to depths of up to 25 metres (80 ft.), which raised constructability concerns with bidding contractors. Maintaining the original concept's geometry, the alternative wall consists of 14 abutting arches with a total length of approximately 250m (800 ft.), as shown in Figure 2. The wall is supported on

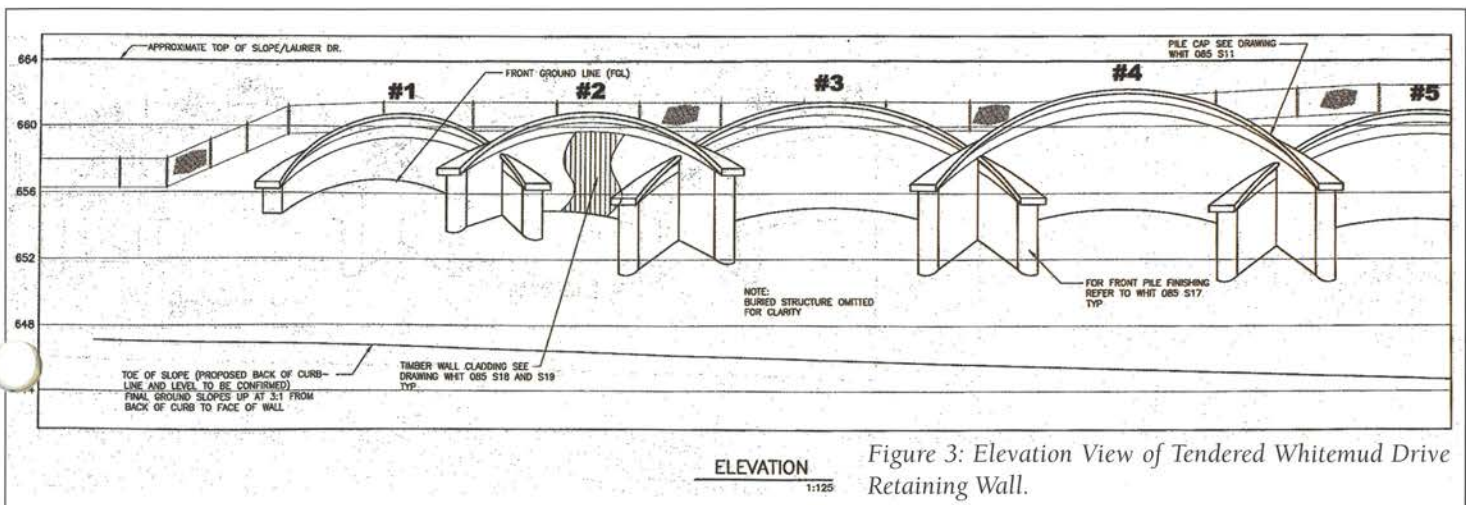
Figure 3: Elevation View of Tendered Whitemud Drive Retaining Wall.

The expansion of the road required the removal of the two-tiered bin walls that were installed following the 1971 slide. The new permanent retaining wall had to be installed further up slope from the original bin wall location. To improve slope stability, the new retaining wall was required to penetrate the historical failure plane in the upper sand layer and anchor into the dense sands below. The tendered retaining wall design used a secant pile arch wall, consisting of 14 overlapping arches, varying in their exposed height above the final grade from 3.0 to 7.9m. This initial retaining wall design consisted of 600mm (24 inch) and 900mm (36 inch) interlocking secant piles, with a "tripod" arrangement of 1200mm (48 inch) secant

piles extending in front of the arch overlaps, as shown in Figure 3. The secant pile concrete strength was specified at 30 MPa (4400 psi) with the deepest piles extending nearly 25m (80 ft.) below the existing grade. A special curved concrete cap was required to improve both the appearance and the structural integrity of the wall, as the secants alone had no lateral reinforcement.

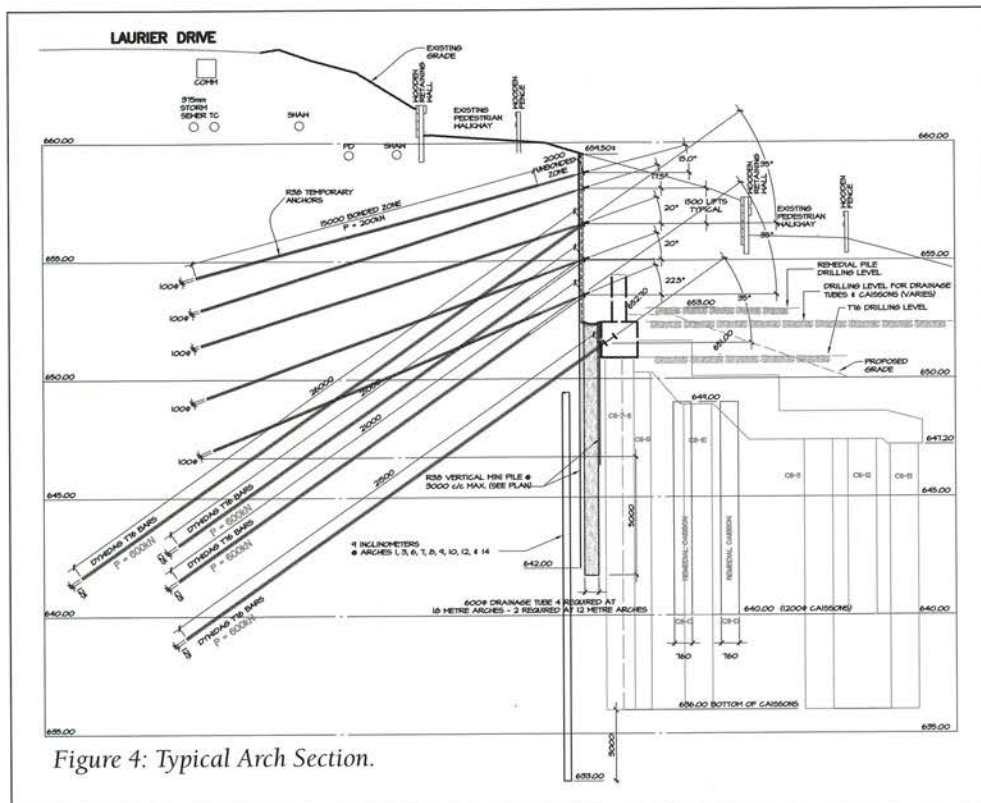
Figure 4: Typical Arch Section.

HCM/Isherwood designed the permanent retaining wall alternative in partnership with Peter Sheffield and Associates, one of Canada's leading structural engineers. The final wall would consist of a 600mm (24 inch) thick cast-in-place arch that would maintain the tripod concept with one distinct difference: the new design would implement construction joints in between arch pairs to allow the loading of the tripods to occur inside of each arch as a "horseshoe" instead of the outside of the overlapping arches as originally designed. This approach would improve crack control in the extreme freeze-thaw environment of Edmonton. Maintenance on the wall would be simplified as arches acting individually could be repaired with fewer complications should problems arise in the future. The lateral reinforcement of a cast-in-place wall improved the structural integrity of the wall, eliminating the structural requirement of the wall cap. Additionally, 600mm (30 inch) drainage tubes positioned below the shotcrete wall and behind the permanent structure would prevent the build-up of hydrostatic pressure from ground water.

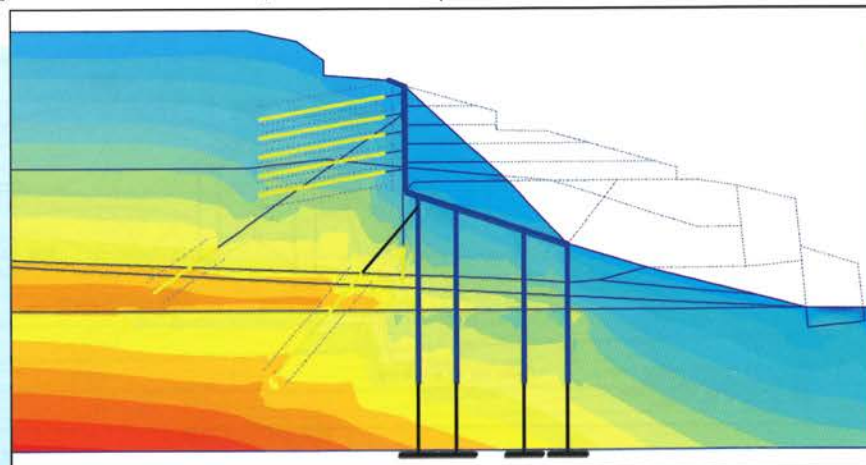
Figure 5: PLAXIS Modeling of Stress Distribution.

The HCM/Isherwood design-build team relied on deformation modeling and subsequent construction slope monitoring to ensure stable performance of the shoring system and confirm the models and design parameters. Loading and resultant deflections for the design were modeled using standard slope stability analysis (limit-equilibrium) and the finite element method to provide guidance for construction progress and staging. Modeling with PLAXIS, a finite-element package used to analyze deformation and stability in geotechnical applications, enabled Isherwood/Sheffield to model the interaction of the structures and the soil.

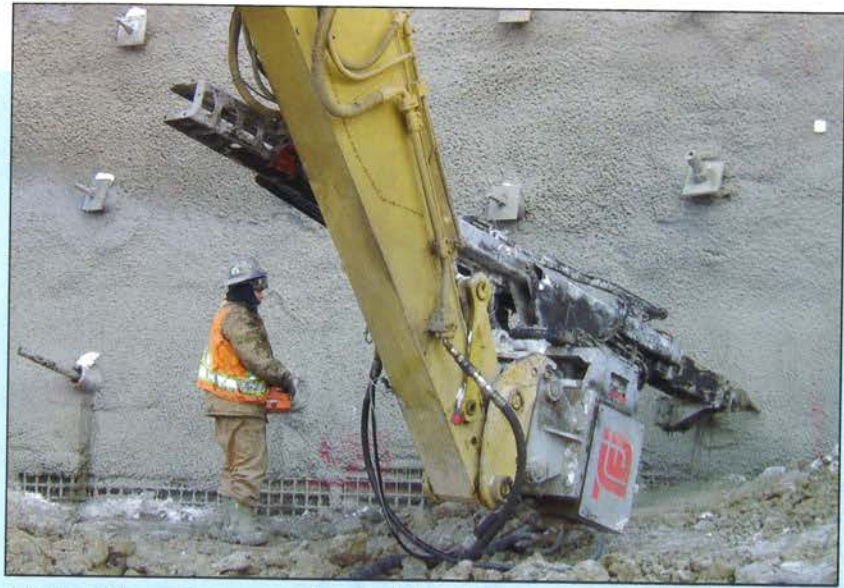
Figure 6: Excavator-mounted TEI Drill.

HCM began construction in October 2008 with the installation of vertical R38 micropiles. These elements were installed between 12m (40 ft.) and 21m (70 ft.) deep into the dense sands by three TEI 550* drills mounted on Caterpillar 320 excavators, as shown in Figure 6. The positioning of the drill attachments to the highly maneuverable excavators facilitated installation of the verticals on the sloped hillside and required minimal excavation prior to drilling. Once verticals were completed, horizontal R38 anchors were installed at

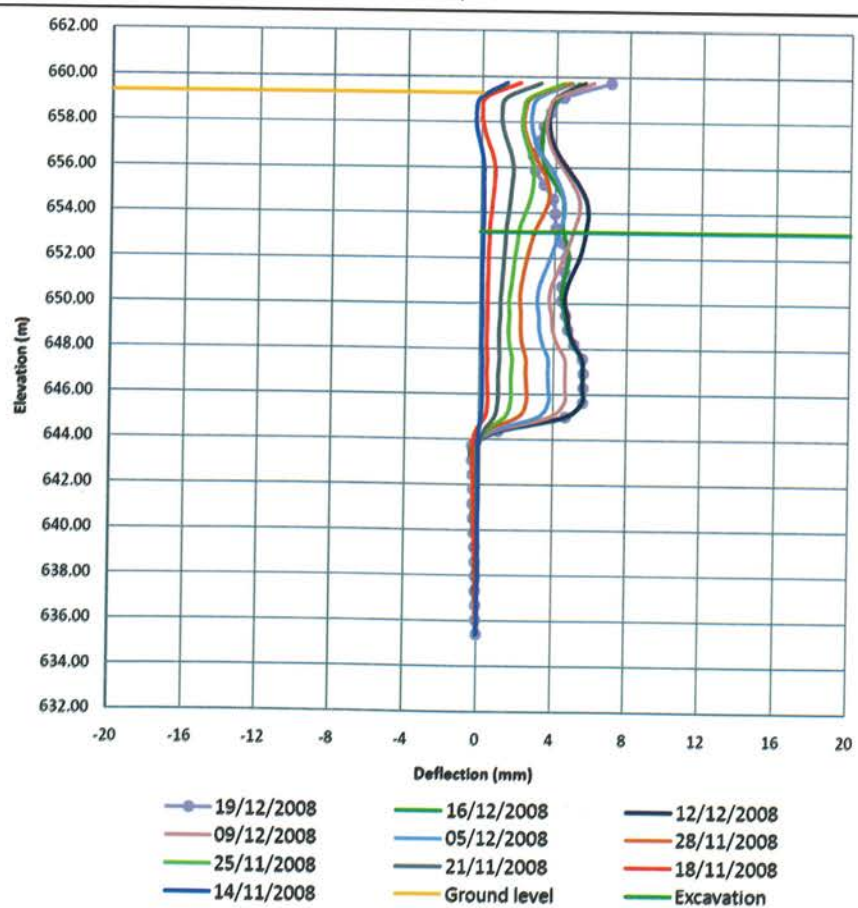
Figure 7: Mid-December Inclinerometer Plot.

As excavation advanced to 6m below the original grade, the inclinometers along the south half of the wall indicated surprisingly large movements over a short vertical distance near the elevation 645.0m, as shown in Figure 7. This coincided with the elevation of the shear movements measured during the 1971 slide, raising concerns as the partially excavated geometry should have provided a high factor of safety. A stop excavation order was put in place for Arches C6 to C14 to allow for back-calculation of soil-strength parameters as a function of the observed hillside deformations. Isherwood immediately began a limit equilibrium analysis based on the as-built condition. The analysis indicated the soil strength parameters of the upper sands to be significantly lower than originally reported in the tender geotechnical report. The actual soil strength parameters of the slope were established assuming that plasticity had occurred within the observed movement layer and, using the limit equilibrium model, determining what soil strength parameters would yield a factor of safety of 1.0. The results of the analysis indicated a significant reduction in the internal angle of friction of the upper clay-seamed sands between the elevations 645 and 646m. The available passive resistance of the soil above this layer was significantly reduced by the weak layer. As an analogy, the resistance of the clay soils above the weak layer could be imagined as a block being pushed on asphalt. Between the elevations 645 and 646 m, it was as if the block was suddenly being pushed on a surface of ice.

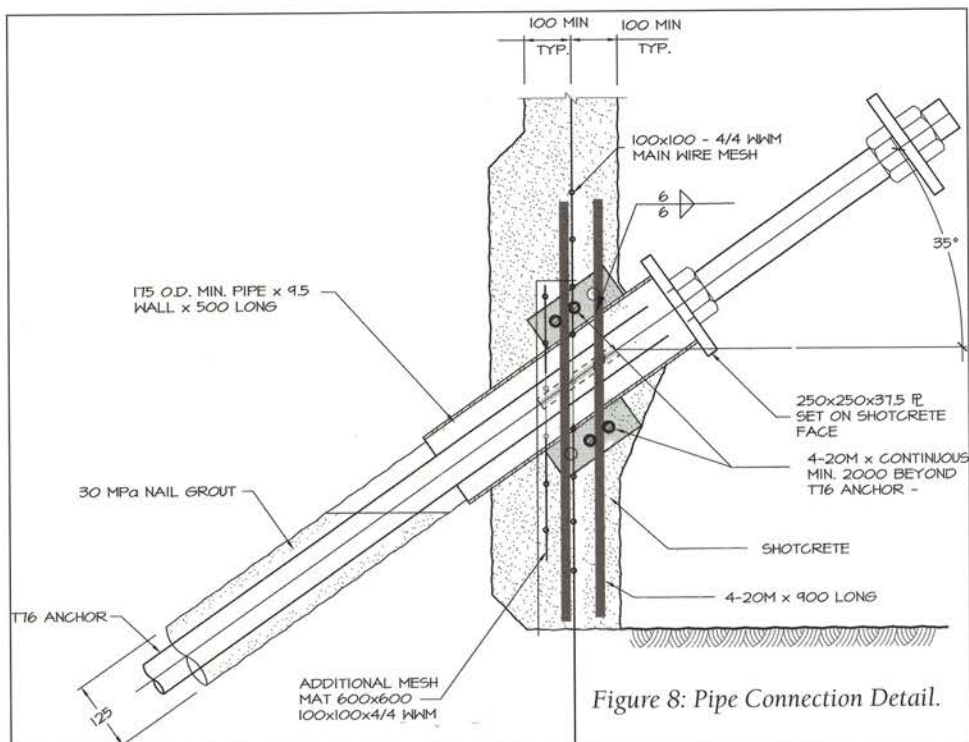
nection at the onset of winter conditions to enable soil cutting and shotcrete application prior to drilling micropiles. Figure 8 shows a 600kN connection that was developed and tested to 900kN on the shotcrete face for the tension piles that were part of the temporary system.

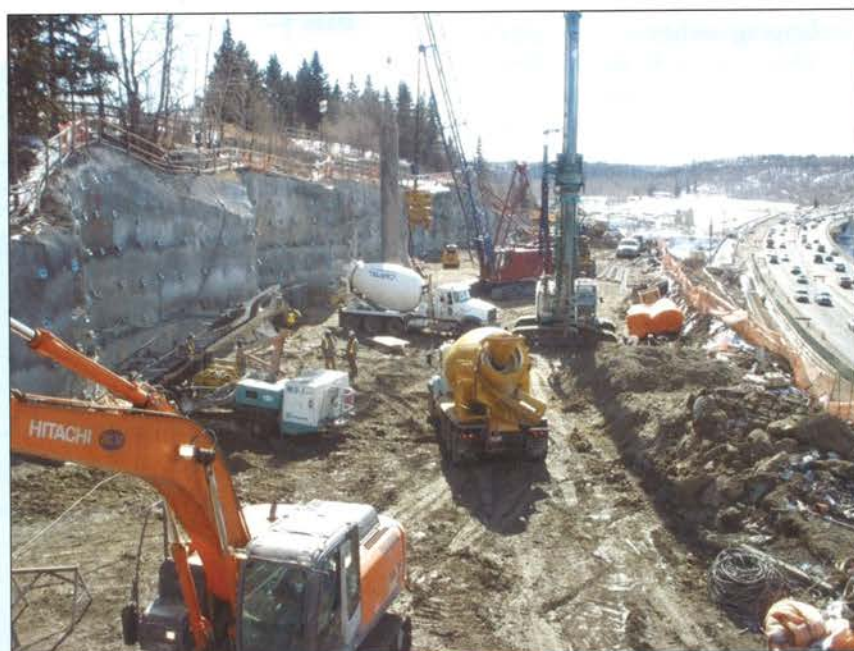
Figure 9: Hillside Congestion.

HCM added further innovation on the project by stepping the base of the shotcrete wall in to act as a back-side form for the ring footing and to be used as a swale to carry surface water through the granular backfill and out from behind the permanent retaining wall via weeping tile. HCM employed two Casagrande M9* hydraulic tieback drills to install the high capacity T76 self-drilling permanent micropiles prior to footing installation. To minimize schedule impacts, multiple operations were run concurrently, which resulted in high hillside congestion, as shown in Figure 8.

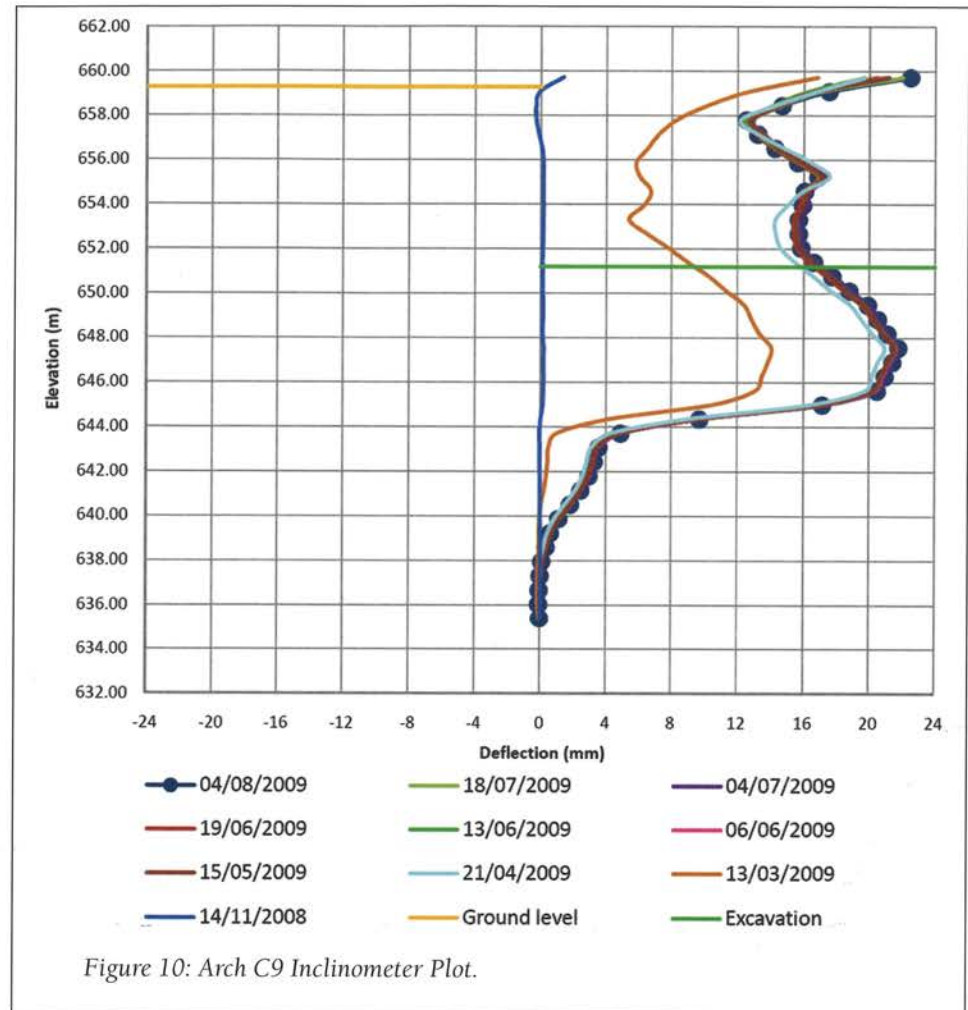
Figure 10: Arch C9 Inclinometer Plot.

At the time of completion, the maximum movement detected along the shotcrete wall was 27 mm (1.1 inches). Figure 9 shows the deep-seated movement near elevation 645m at Arch C9. The upper tier of the double bin wall was removed first, the monitoring observed and then, with all ring footings in place, the complete low slope was removed. Performance has proven to be stable and no creep has been observed, demonstrating a successful conclusion to a logistically difficult and technically challenging project.
