Instrumentation and performance of tied-back shotcrete shoring in sand adjacent to a hospital structure

Abstract: Recent additions to the Brantford General Hospital expansion included construction of a new hospital wing, involving excavations of up to 11 metres (36 feet) depth, in loose to compact sand adjacent to an existing eight-storey hospital structure. The tendered contract called for interlocking caisson walls. An alternative, proposed by HC Matcon Ltd., was to use tied-back shotcrete shoring as the method of temporary excavation support. Due to a lack of familiarity with this method in the area, the uncertainty of attaining near-zero movements, and the proximity of adjacent 'lifeline' structures, the design-build team of HC Matcon and Isherwood Associates implemented a comprehensive program of quality control assurance.

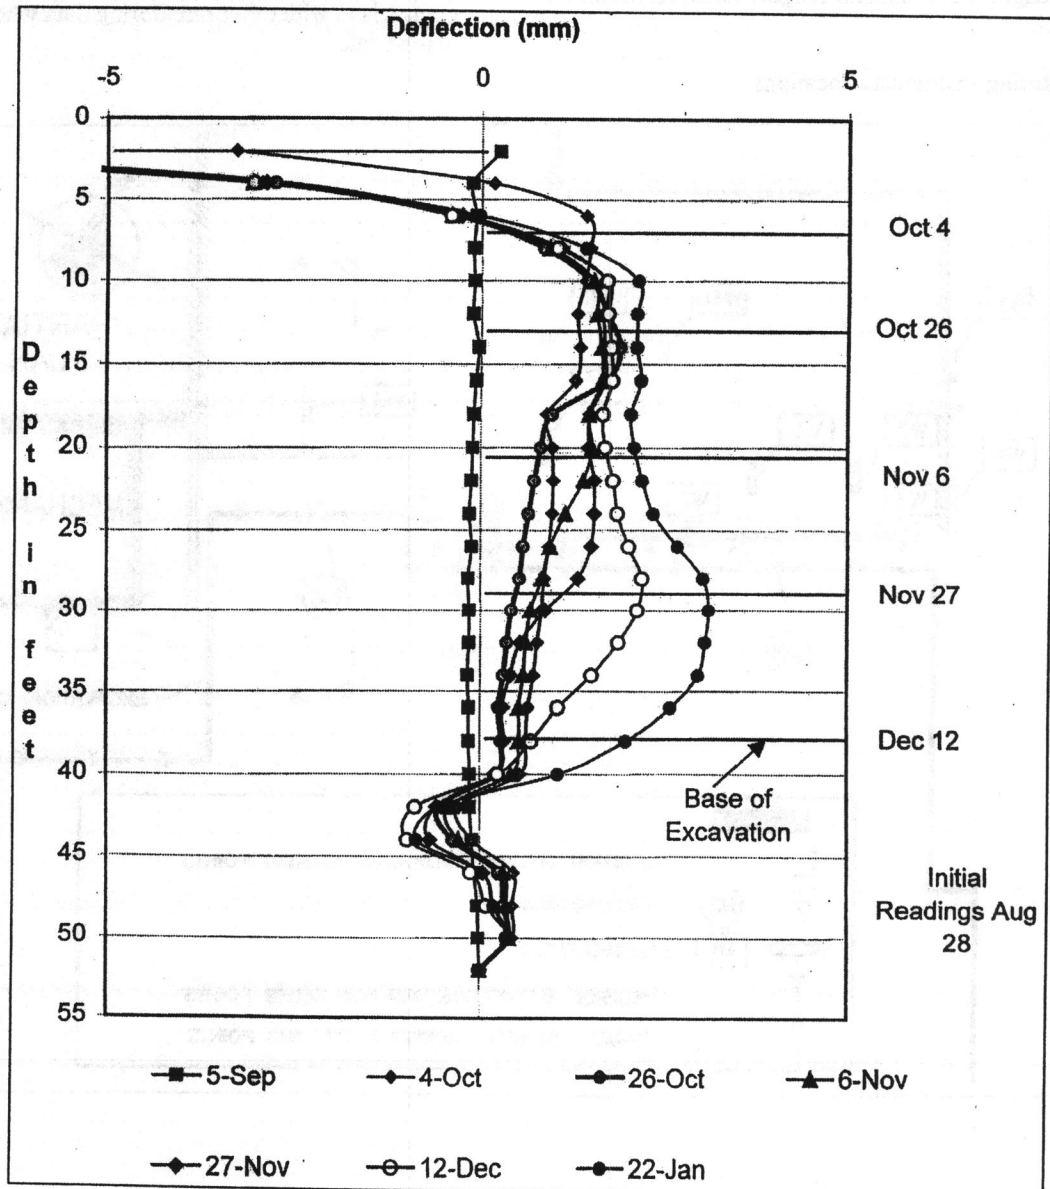
Fig 6. Displacement Plot for Inclinometer NE

Inclinometer plot NE, displayed in Fig. 6, showed characteristic into-site "bulges" concurrent with local excavation of each four-foot lift. The time period between lifts, from initial berm excavation to final tieback stressing varied from four to fourteen days. The maximum displacements, or "bulges", generally occurred

near the base of the lift most recently excavated. Above the active lift, where shotcrete wall construction and tieback stressing had been completed, inclinometer displacements were negligible. For example, between October 26 and December 12, inclinometer plot NE indicated almost no change between depths 10 and 16 feet, while 1.4 millimetres of into-site displacement was measured at 28 feet.

Upon completion of all excavation and shotcrete wall construction, the maximum relative into-site displacement was 2.2 millimetres. Additional post-excavation displacements, mainly attributed to compaction vibrations, increased the maximum displacement to 3.3 millimetres or 0.03 percent of the excavation depth.
